Design Guide

for Improving School Safety
in Earthquakes, Floods, and High Winds

6 Making Schools Safe From High Winds

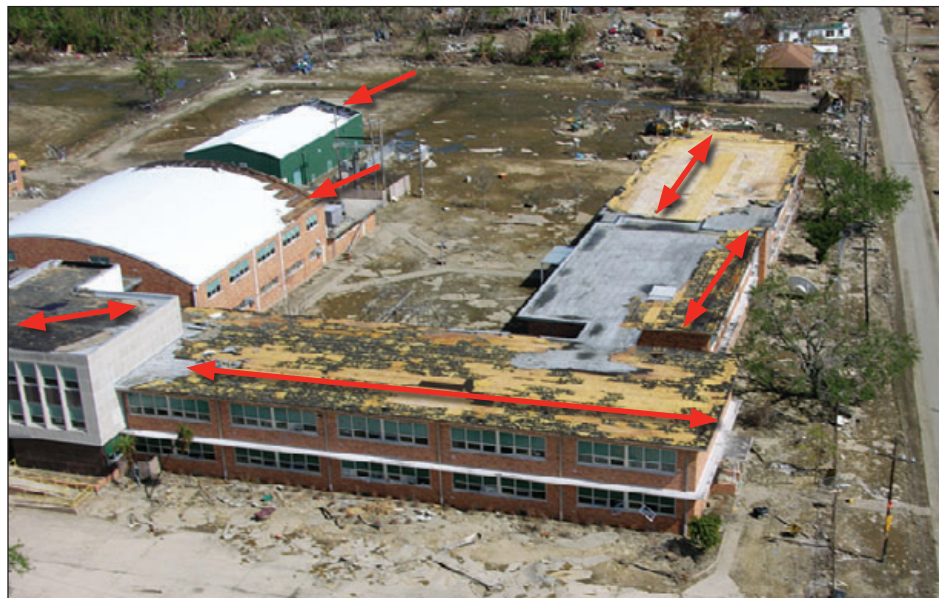
Figure 6-1:
Large portions of the roof coverings blew off of this school. Estimated wind speed: Approximately 125 to 130 miles per hour (mph).² Hurricane Katrina (Louisiana, 2005)

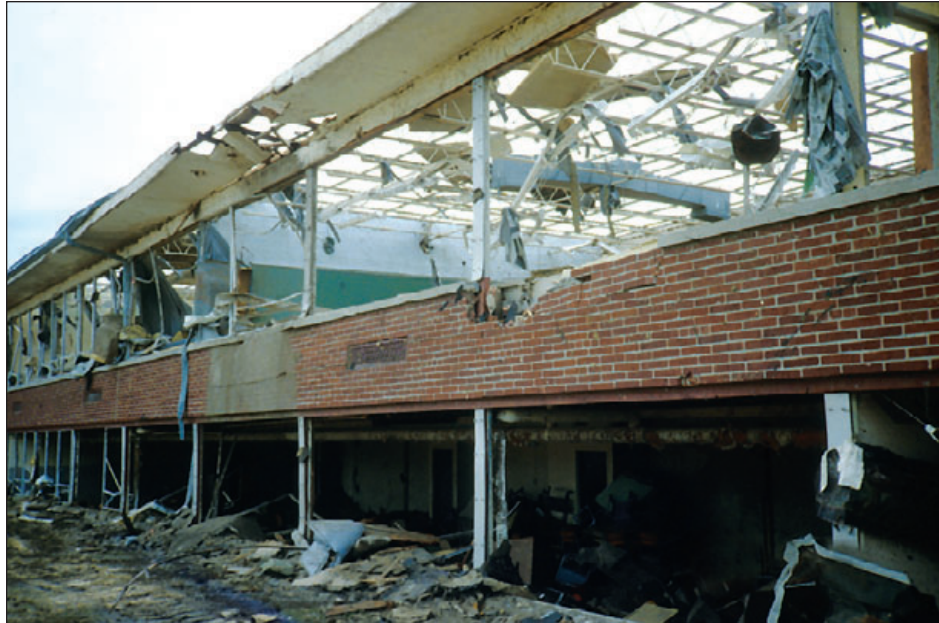
Figure 6-4:
This high school was
damaged by a strong
tornado (Plainfield, IL
1990)

In the classroom wing shown in Figure 6-4, all of the exterior windows were broken, and virtually all of the cementitious wood-fiber deck panels were blown away during a tornado. Much of the metal decking over the band and chorus area also blew off. The gymnasium collapsed, as did a portion of the multi-purpose room. The school was not in session at the time the tornado struck. See Section 6.5 for recommendations pertaining to tornadoes.

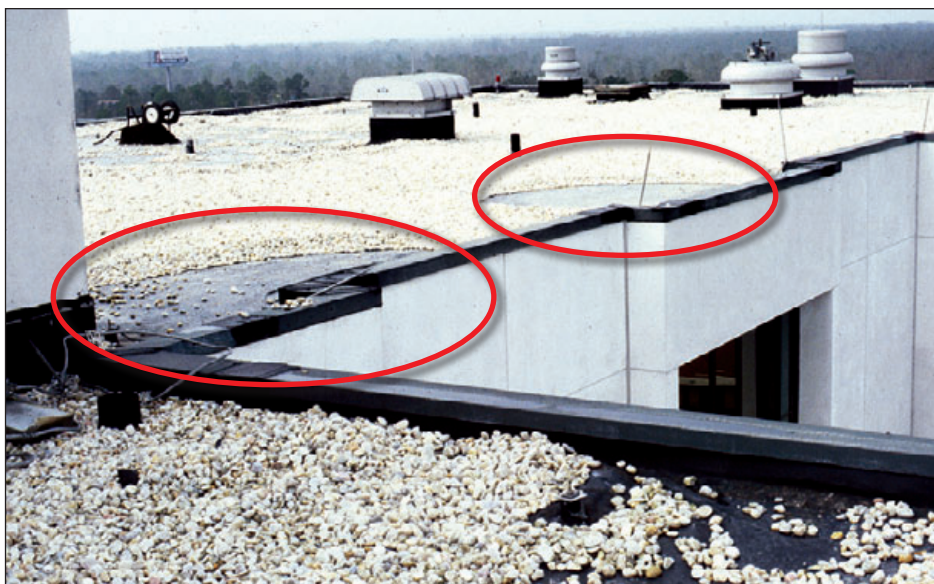
Figure 6-8:
Aggregate blow-off
associated with building
irregularities. Hurricane
Hugo (South Carolina,
1989)

Building irregularities, such as re-entrant corners, bay window projections, a stair tower projecting out from the main wall, dormers, and chimneys can cause localized turbulence. Turbulence causes wind speed-up, which increases the wind loads in the vicinity of the building irregularity, as shown in Figures 6-8 and 6-9. Figure 6-8 shows the aggregate ballast on a building's single-ply membrane roof blown away at the re-entrant corner and in the vicinity of the corners of the wall projections at the window bays. The irregular wall surface created turbulence, which led to wind speed-up and loss of aggregate in the turbulent flow areas.

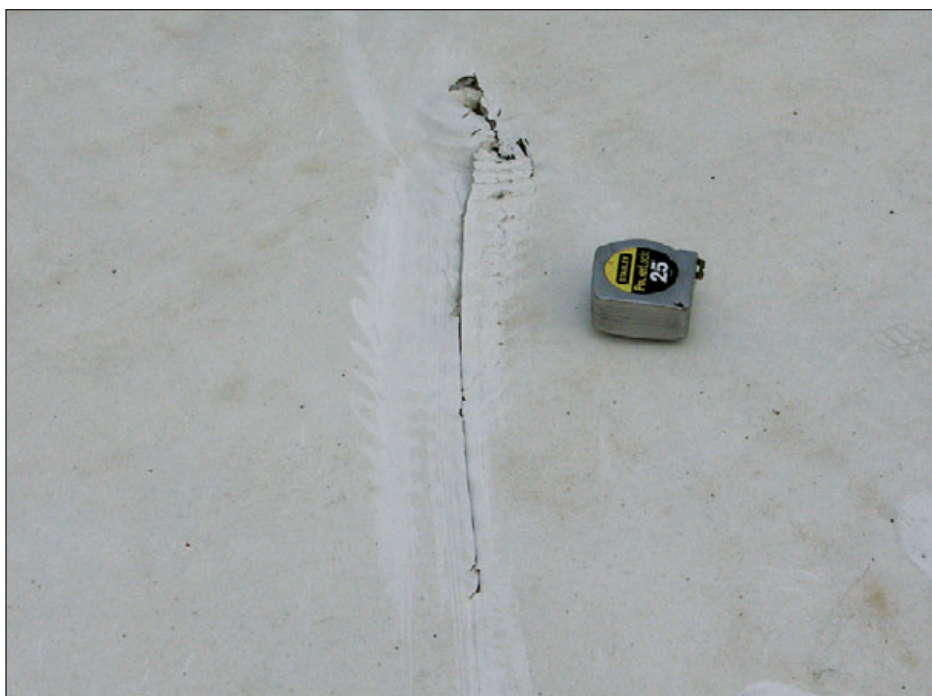
Figure 6-11: The single-ply roof membrane on this school was torn by a missile. The tear was still unprotected 6 days after it was damaged. A substantial amount of water can enter the building through such a tear, unless the deck is water tight (see Figure 6-13) or a secondary roof membrane is used as discussed in Section 6.3.3.7. Estimated wind speed: 105 to 115 mph. Hurricane Ivan (Florida, 2004)

- They do not account for water infiltration due to puncture of the roof membrane by missiles (see Figure 6-11)
- They do not adequately address the vulnerabilities of brittle roof coverings (such as tile) to missile-induced damage and subsequent progressive failure
- For schools used as hurricane recovery centers after a hurricane, they do not account for interruption of water or sewer service or prolonged interruption of electrical power.

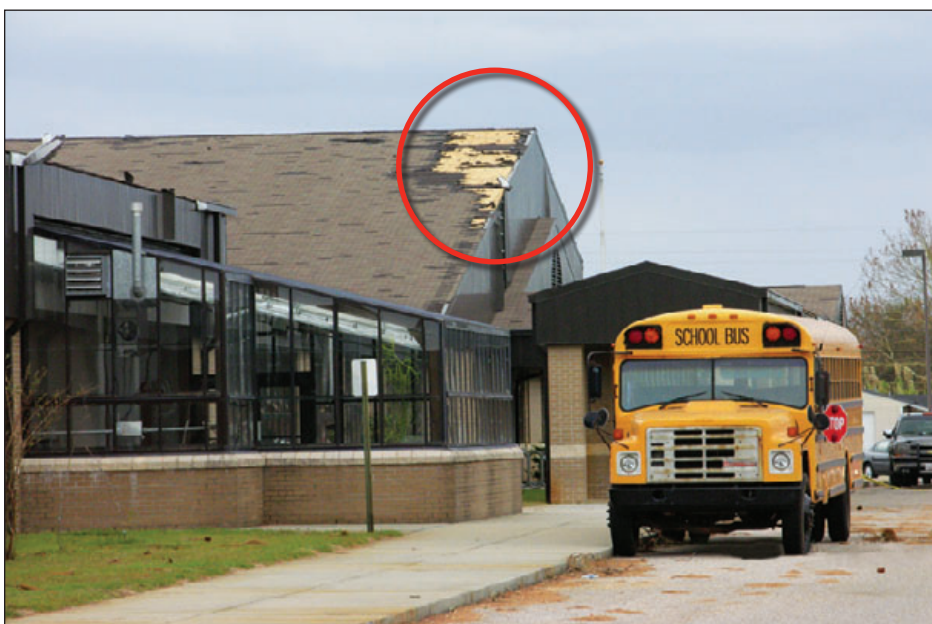
Figure 6-12: Constructed in 1995, this school was used as a hurricane shelter. The large number of occupants moved from one area of the school to another as water entered various areas of the building due to envelope failures. Estimated wind speed: 105 to 115 mph. Hurricane Ivan (Florida, 2004)

When damaged by wind, schools typically experience a variety of building component damage. For example, at the school shown in Figure 6-12, the roof covering was severely damaged, metal wall panels were blown off, and rooftop equipment was blown away. Water entered the building at all of these envelope breaches. The most common types of damage are discussed below in descending order of frequency.

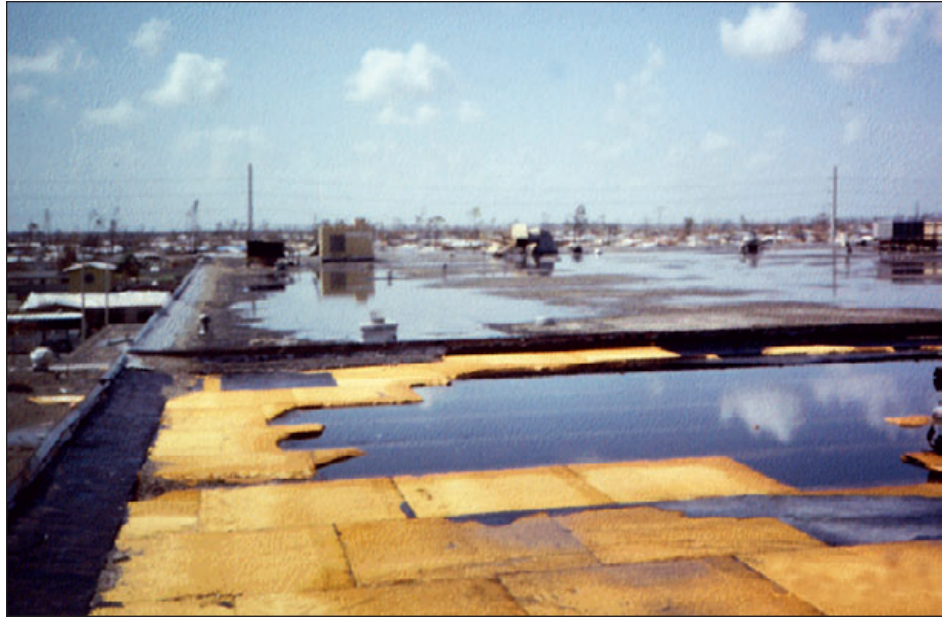
Figure 6-13:
Extensive roof covering and rooftop equipment damage occurred on this school. However, the cast-in-place concrete deck kept most of the water from entering the school. Hurricane Andrew (Florida, 1992)

Roof: Roof covering damage (including rooftop mechanical, electrical, and communications equipment) is the most common type of wind damage, as illustrated by Figure 6-13. At this school, a portion of the built-up membrane lifted and peeled after the metal edge flashing lifted. The cast-in-place concrete deck kept most of the water from entering the building. Virtually all of the loose aggregate blew off the roof and broke many windows in nearby houses. This school was used as a hurricane shelter at the time of the blow-off.

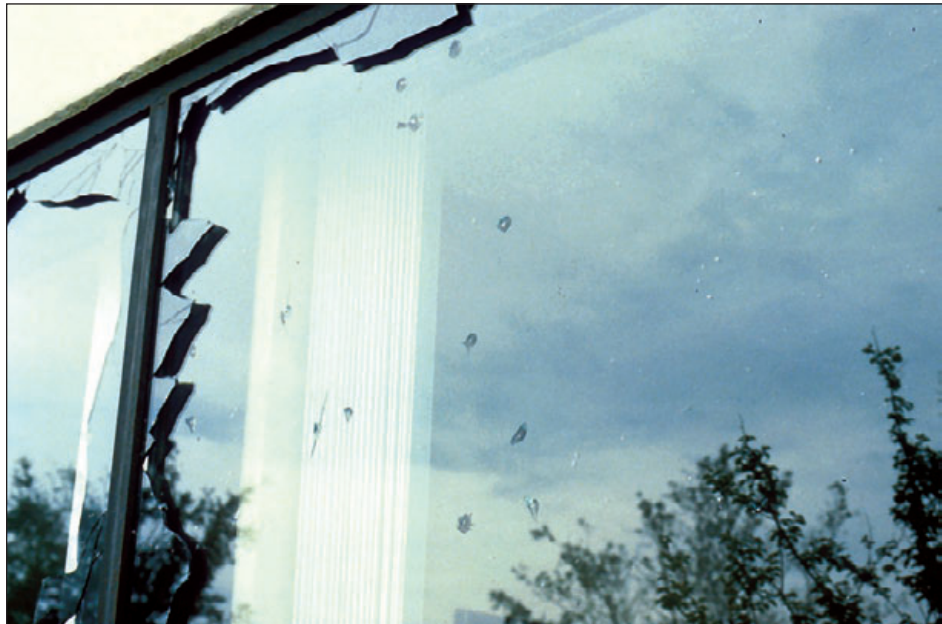
Figure 6-14:
The outer window panes were broken by aggregate from a built-up roof. Estimated wind speed: 104 mph. Hurricane Hugo (South Carolina, 1989)

Glazing: Exterior glazing damage is very common during hurricanes and tornadoes, but is less common during other storms. The glass shown in Figure 6-14 was broken by the aggregate from a built-up roof. The inner panes had several impact craters. In several of the adjacent windows, both the outer and inner panes were broken. The aggregate flew more than 245 feet.

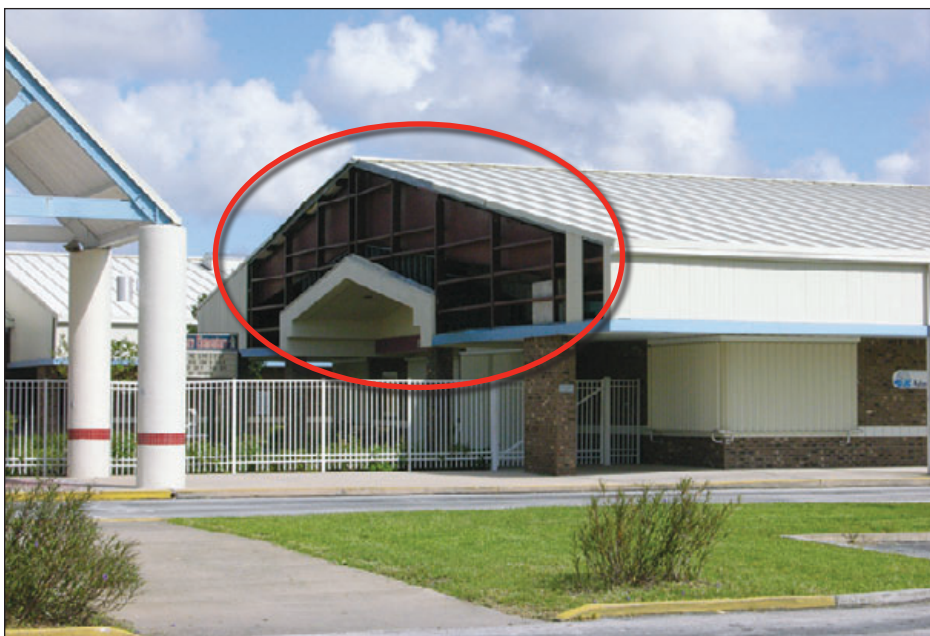
Figure 6-15:
Blow-off of metal wall panels allowed wind-driven rain to enter this school. Hurricane Frances (Florida, 2004)

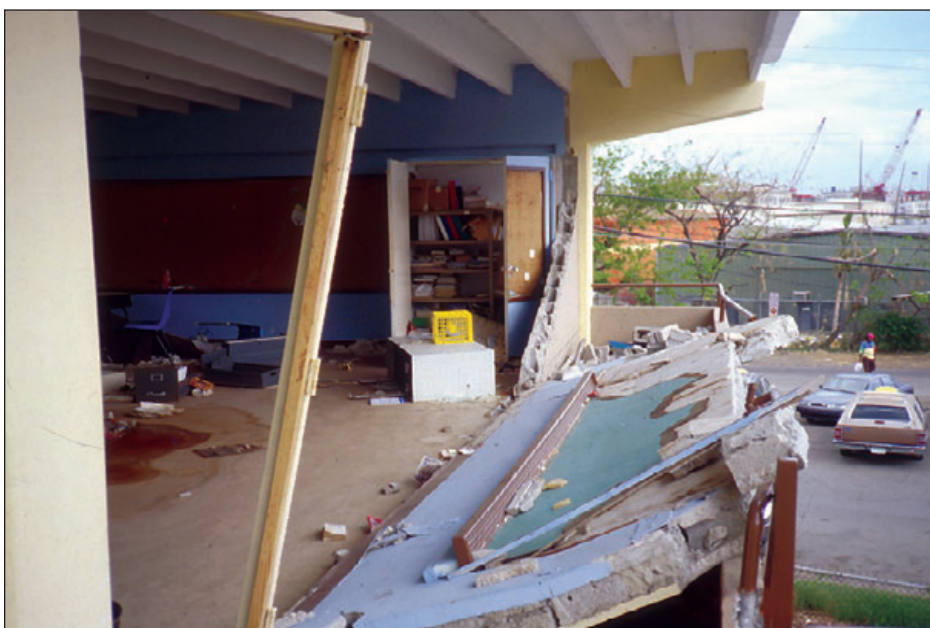
Figure 6-16:
Collapsed unreinforced CMU wall. Hurricane Marilyn (U.S. Virgin Islands, 1995)

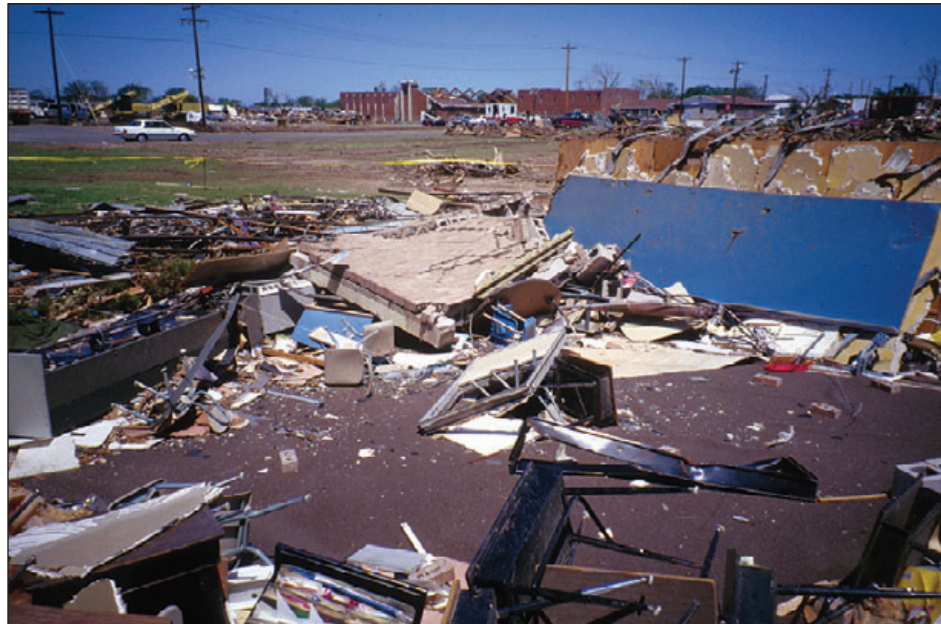
Figure 6-18:
This elementary school was composed of several buildings. The building in the foreground collapsed and several others experienced significant structural damage. The buildings further up the hillside are residences. Hurricane Marilyn (U.S. Virgin Islands, 1995)

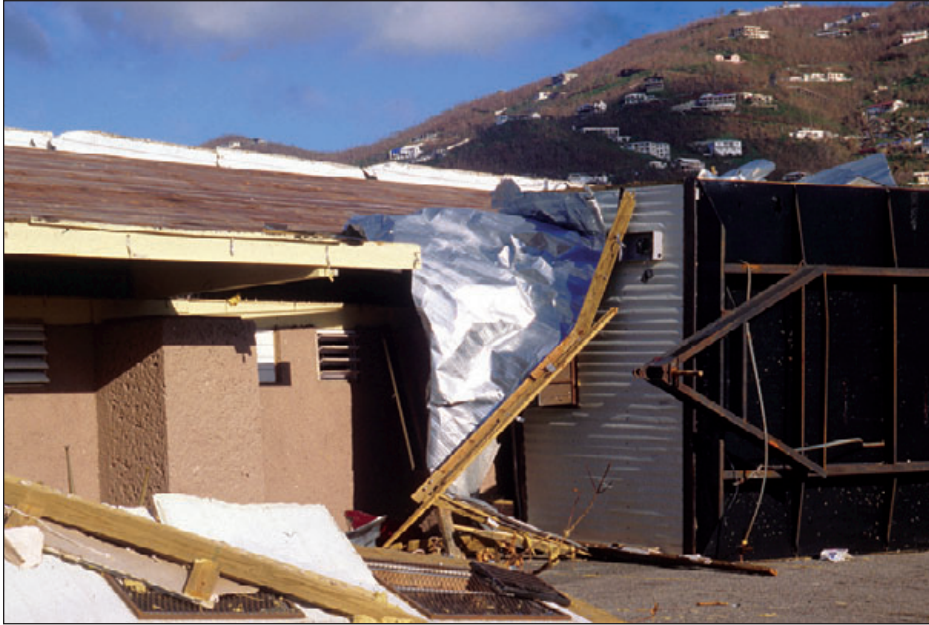
Figure 6-19: This portable classroom was blown up against the main school building. Depending upon the type of exterior wall, an impacting portable classroom may or may not cause wall collapse. Hurricane Marilyn (U.S. Virgin Islands, 1995)

Structural system: Structural damage (e.g., roof deck blow-off, blow-off or collapse of the roof structure, collapse of exterior bearing walls, or collapse of the entire building or major portions thereof) is the principal type of damage that occurs during strong and violent tornadoes (see Figure 6-17). Structural damage occasionally occurs during hurricanes (Figures 6-18, 6-21, 6-24, 6-26, and 6-34). Portable classrooms are also sometimes severely damaged or overturned as shown in Figure 6-19.

Portable classrooms are often particularly vulnerable to significant damage because they are seldom designed to the same wind loads as permanent school buildings. Portable classrooms are frequently blown over during high-wind events because of the inexpensive techniques typically used are inadequate to anchor the units to the ground (see Figures 6-19 and 6-22). Wind-borne debris from portables or an entire portable classroom may impact the permanent school building and cause serious damage (Figure 6-19).

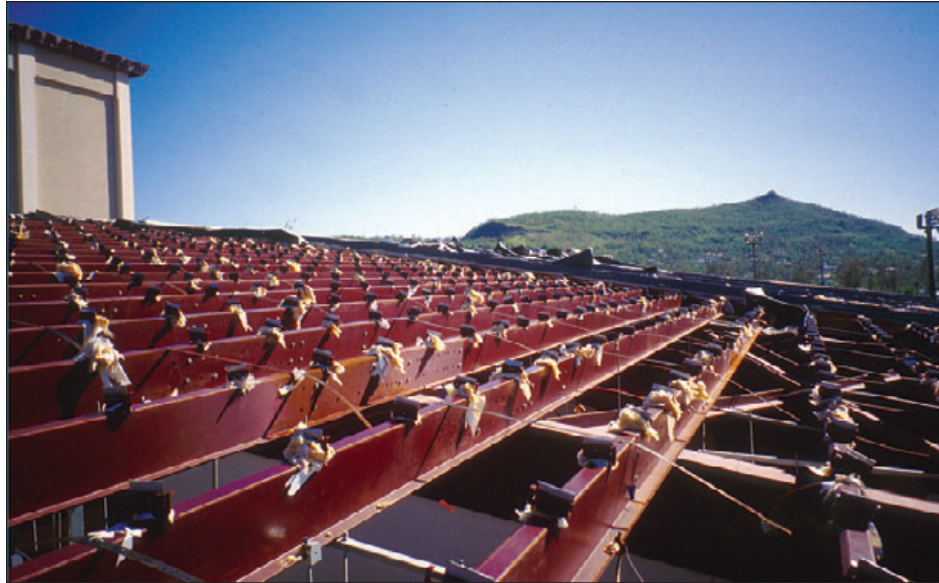
Figure 6-20:

This newly-constructed gymnasium had a structural metal roof panel (3-inch trapezoidal ribs at 24 inches on center) applied over metal purlins. The panels detached from their concealed clips. A massive quantity of water entered the school and buckled the wood gym floor. Typhoon Paka (Guam, 1997)

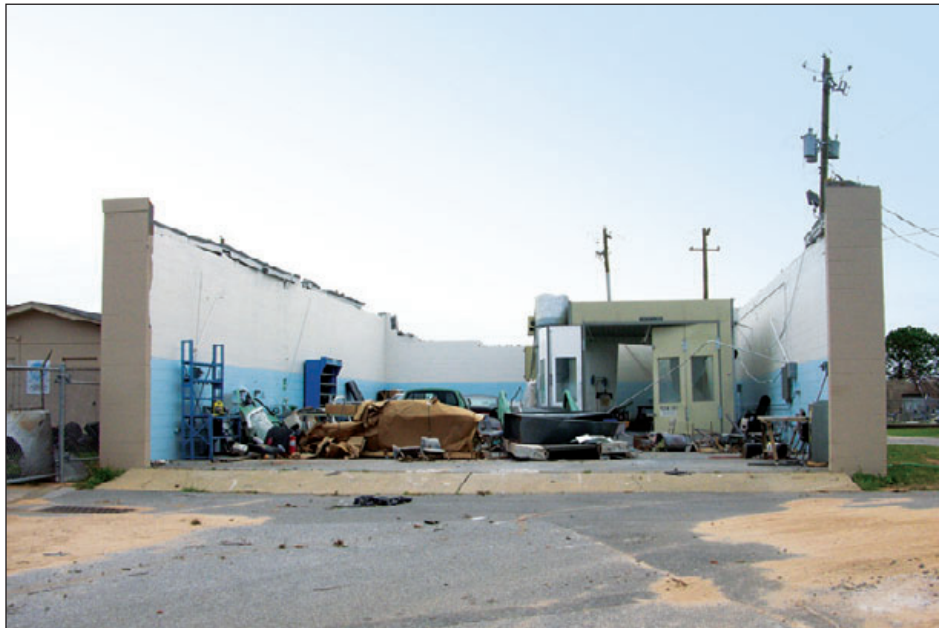
Figure 6-21:

The entire metal deck and steel joist roof structure at this school's auto shop blew off. Estimated wind speed: 105 to 115 mph. Hurricane Ivan (Florida, 2004)

Ancillary buildings (such as storage or shop buildings) adjacent to schools are also vulnerable to damage. Although loss of these buildings may not be crippling to the operation of the school, debris from ancillary buildings may strike and damage the school (Figure 6-21).

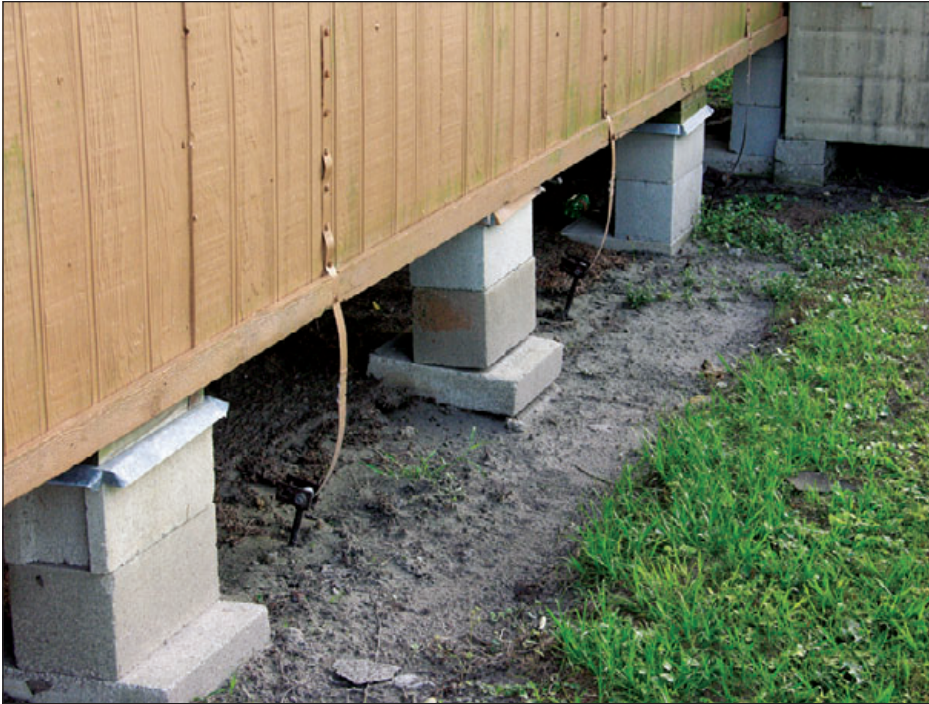
Figure 6-22:
The metal straps between this portable classroom and the ground anchors were not taut. This classroom is susceptible to being blown off the piers and to overturning. See Figure 6-27 for a robust anchoring system.

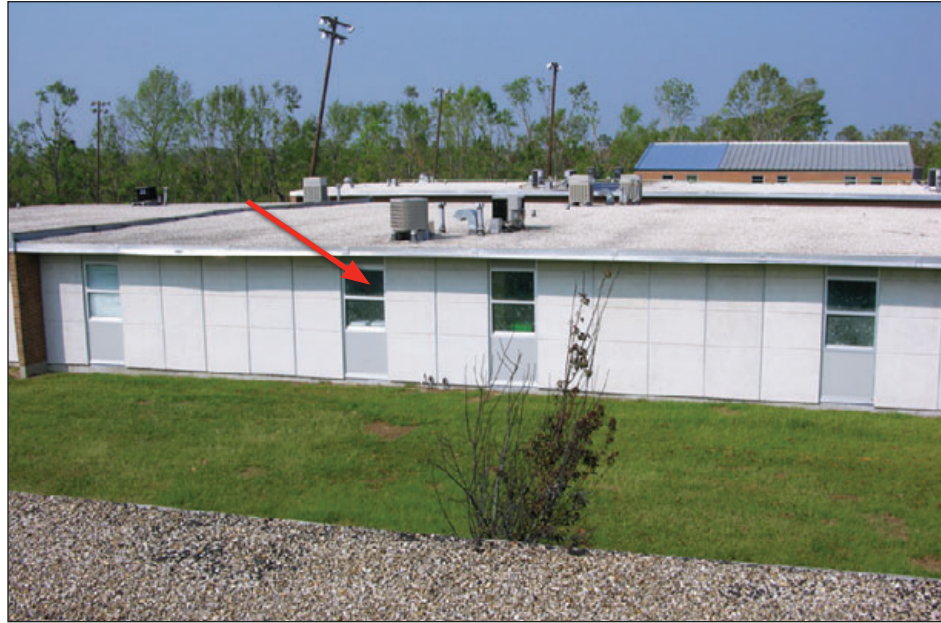
Figure 6-23:

This old school was used as a hurricane shelter. Structural failure did not occur during this hurricane. However, portions of the roof covering were blown off, rooftop equipment was damaged, and many windows were broken by aggregate from the built-up roof (red arrow). Estimated wind speed: 130 mph. Hurricane Katrina (Mississippi, 2005)

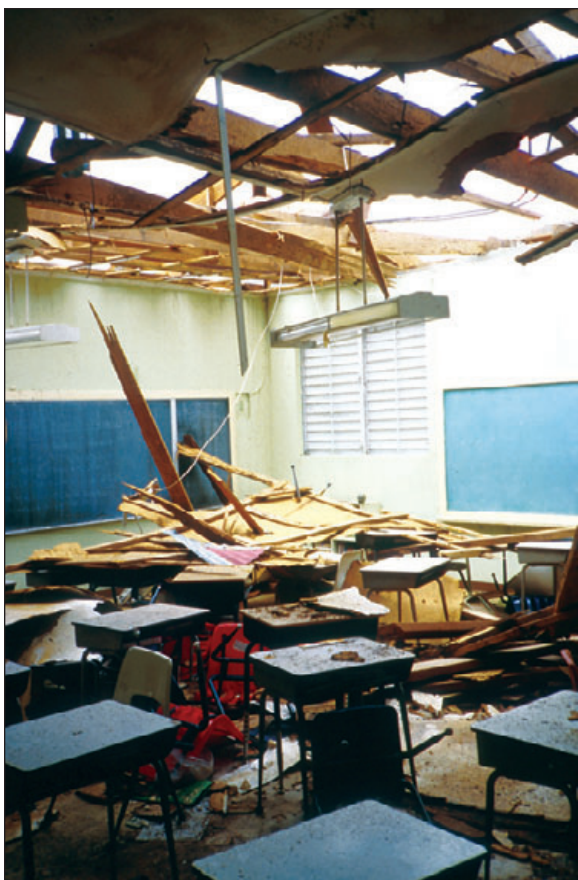
Figure 6-24:

A portion of the roof structure blew off this school, and a portion of it collapsed into classrooms. Extensive water damage can cause such a school to be out of operation for a considerable period of time. Hurricane Marilyn (U.S. Virgin Islands, 1995)

Interrupted use: Depending upon the magnitude of wind and water damage, it can take days, months, or more than a year to repair the damage or replace a facility (see Figure 6-24). In addition to the costs associated with repairing/replacing the damage, other social and financial costs can be even more significant. Additional costs related to interrupted use of schools can include the cost of bussing students to alternative schools and/or rental of temporary facilities, and can be quite substantial.

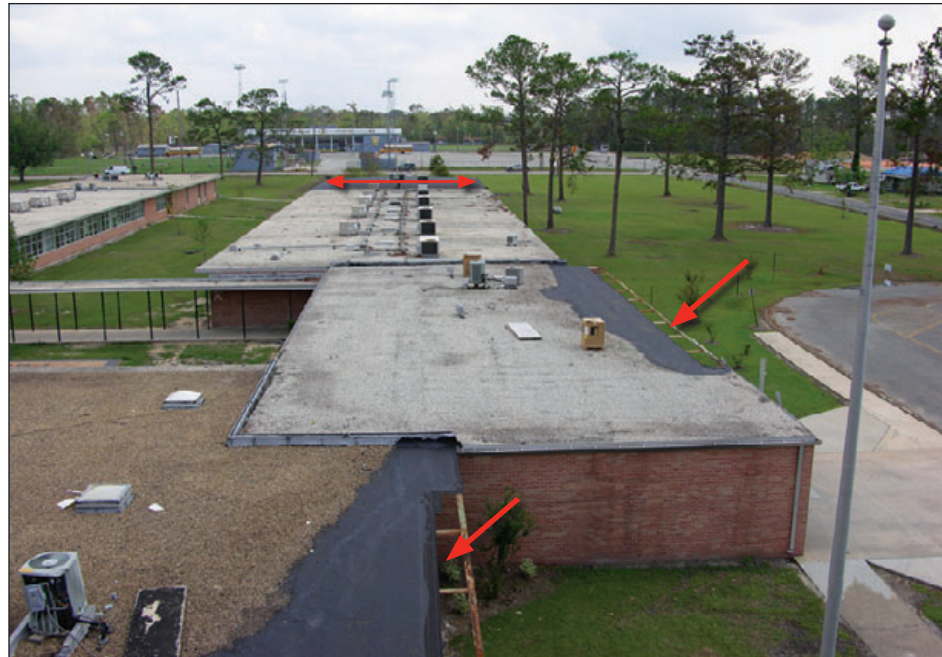
Figure 6-26:
The cementitious wood-fiber deck panels blew off the overhangs and caused a progressive lifting and peeling of the roof membrane. Strengthening (or replacing) inadequately attached roof decks during a reroofing project is both prudent and relatively economical. Estimated wind speed: 120 mph. Hurricane Katrina (Mississippi, 2005)

Costs can be minimized if wind-resistance improvements are executed as part of planned repairs or replacement. For example, if the roof deck is inadequately attached in the perimeter and corners (see Figure 6-26), and the roof covering has another 10 years of remaining service life, it would typically be prudent to postpone performing deck attachment upgrade until it is necessary to replace the roof covering. Then, as part of the reroofing work, the existing roof system could be torn off, the deck reattached or replaced, and the new membrane installed.⁹ This approach provides the cost benefit of utilizing the full service life of the roof membrane.

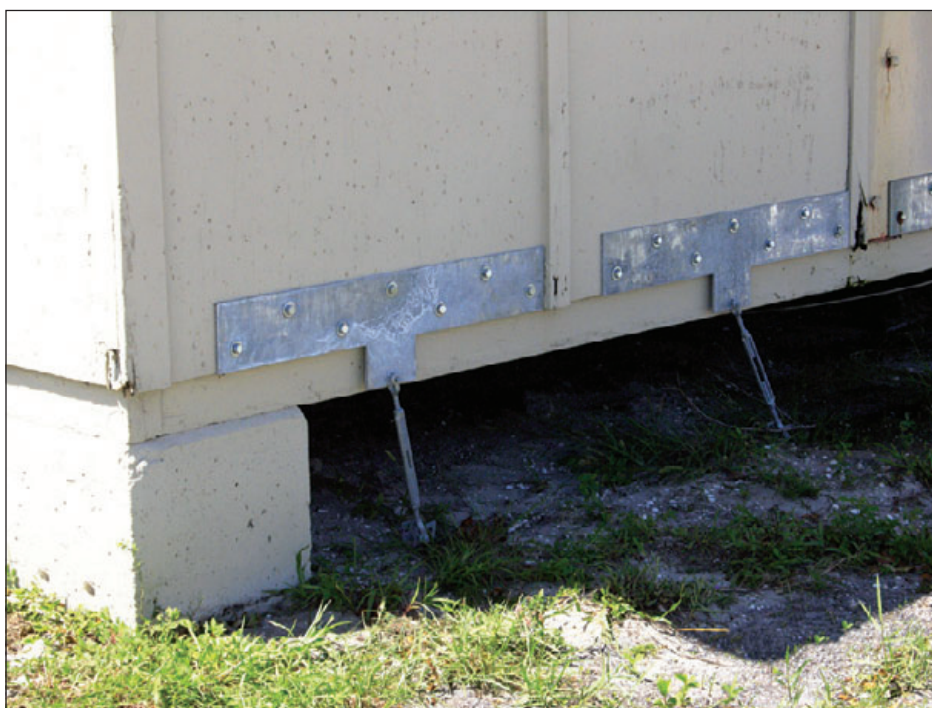
Figure 6-27: Unlike the portable classroom shown in Figure 6-22, with the thick T-shaped plates and taut turnbuckles, this portable classroom has a robust anchorage to the ground. Hurricane Francis (Florida, 2004)

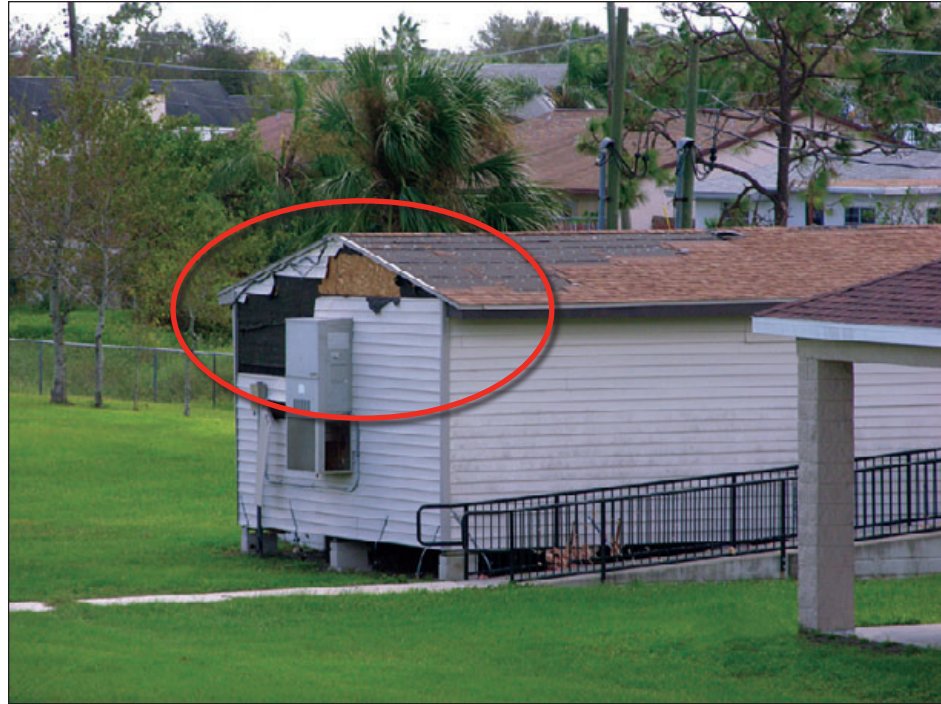
Figure 6-28:
Asphalt shingles and vinyl siding blew off of this portable classroom. This type of wind-borne debris can break unprotected glazing. Hurricane Francis (Florida, 2004)

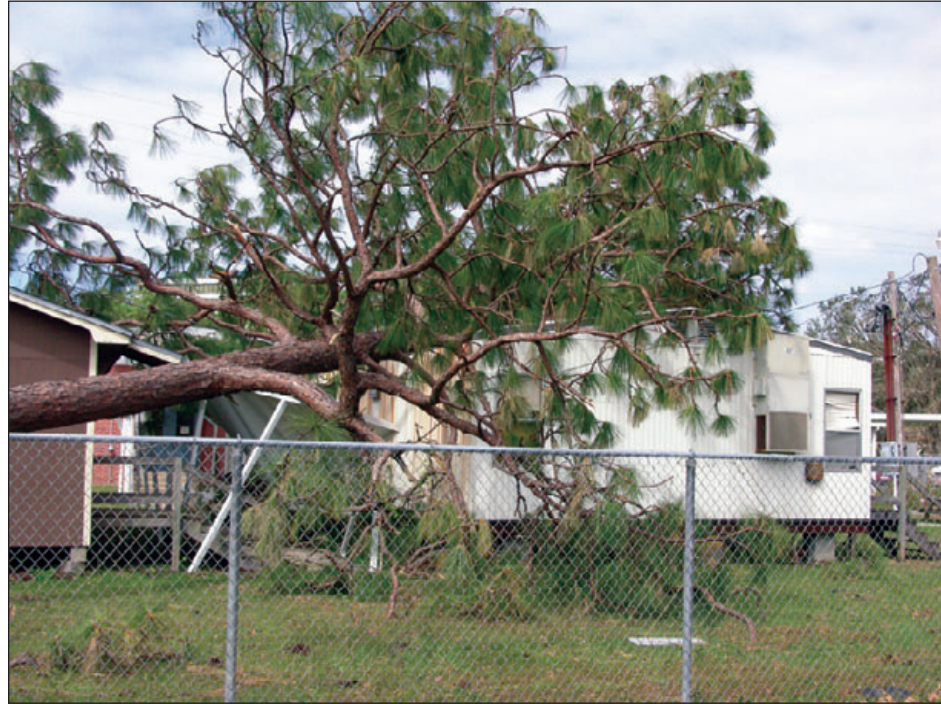
Figure 6-29:

This fallen tree caused minor damage to these portable classrooms. However, had the tree landed on the classroom at the left of the photograph, it could have caused injuries if the building had been occupied. Although portable classrooms are not occupied during hurricanes, they are frequently occupied during thunderstorms, which often topple trees. Estimated wind speed: 105 to 115 mph. Hurricane Ivan (Florida, 2004)

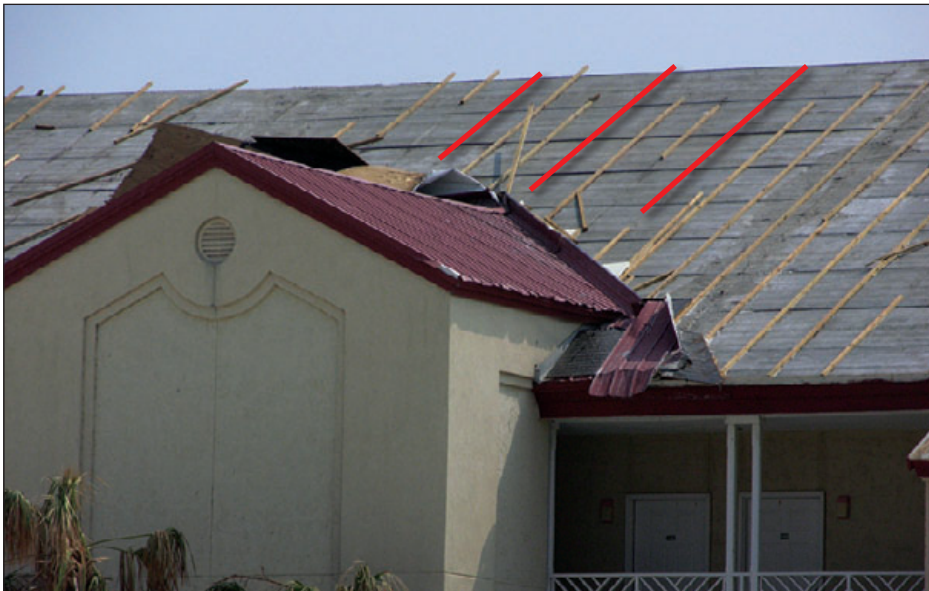
Figure 6-30: In most of the areas on this roof, the connection of the top nailer to the bottom nailer was the weakest link. However, in a few locations, the connection of the bottom nailer to the roof structure was the weak link (three of the blown-off bottom nailers are shown by the red lines).

As part of the detailed design effort, load path continuity should be clearly indicated in the contract documents via illustration of connection details. Load paths need to accommodate design uplift, racking, and overturning loads. Load path continuity obviously applies to MWFRS elements, but it also applies to building envelope elements. Figure 6-30 shows load path discontinuities within a roof covering system. In this system, metal roof panels were attached to plywood, which was attached to 4x4 nailers running cross-slope. These top nailers were attached to 4x4 nailers that ran up-slope. The top nailers were inadequately attached to the bottom nailers and the bottom nailers were inadequately attached to the roof structure. To effectively attach the top nailer to the bottom nailer, high-strength connectors such as metal framing connectors are needed. To effectively attach the bottom nailers, a variety of fasteners may be used, provided a sufficient number are used.

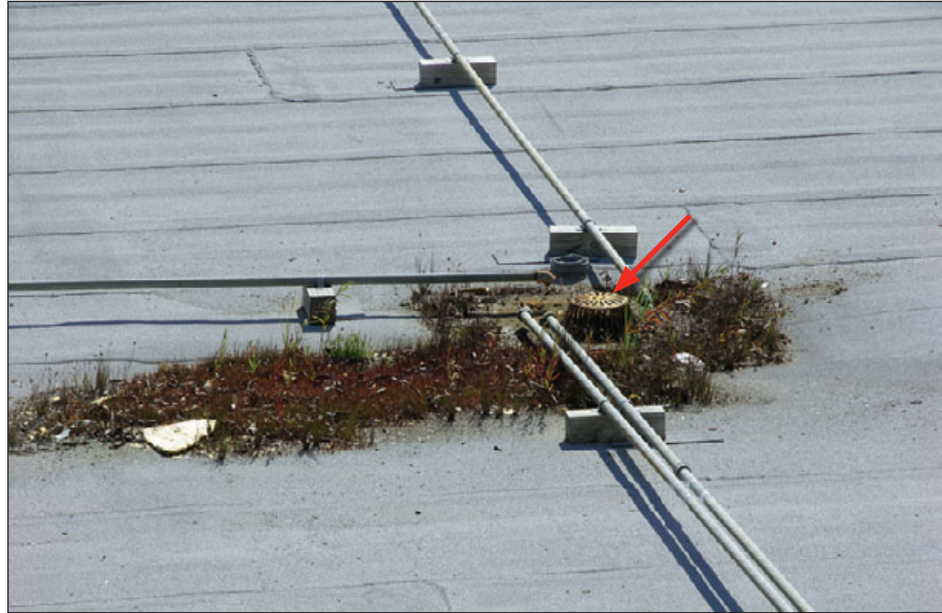
Figure 6-32:
Dirt and vegetation
surrounded this roof
drain (red arrow) and
impeded drainage.
Roof drains should
be checked at least
annually and cleaned of
debris if found. Drains
should also be checked
prior to hurricane
landfall. Hurricane Ike
(Texas, 2008)

Prior to hurricane landfall, a special roof inspection is recommended. Remove debris and other items that are not anchored so that they do not become wind-borne debris. Also, clean roof drains and sumps so that their drainage capacity is not impaired (see Figure 6-32). Lack of debris maintenance can lead to clogging. If overflow drains or scuppers are also clogged, roof collapse may occur.

As part of pre-storm preparations, drains, scuppers, and gutters should be cleaned of debris in order to maximize their effectiveness in draining the roof and minimize the potential for their blockage during a hurricane (see Figure 6-32).

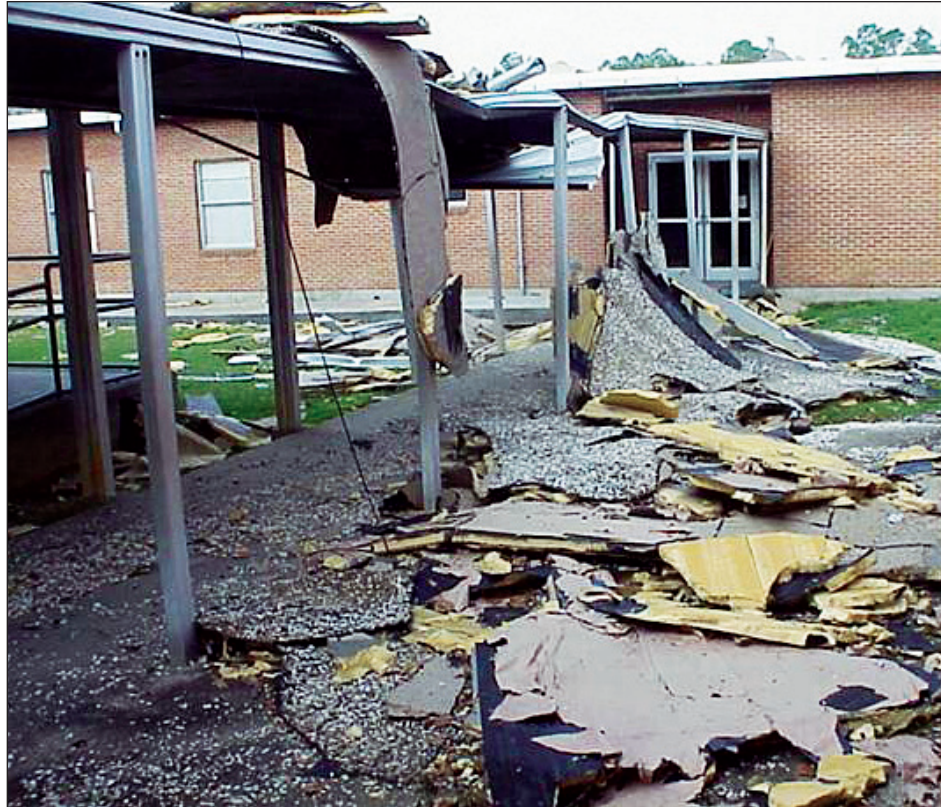
Figure 6:33:
Open walkways do not
provide protection from
wind-borne debris.
Hurricane Katrina
(Mississippi, 2005).

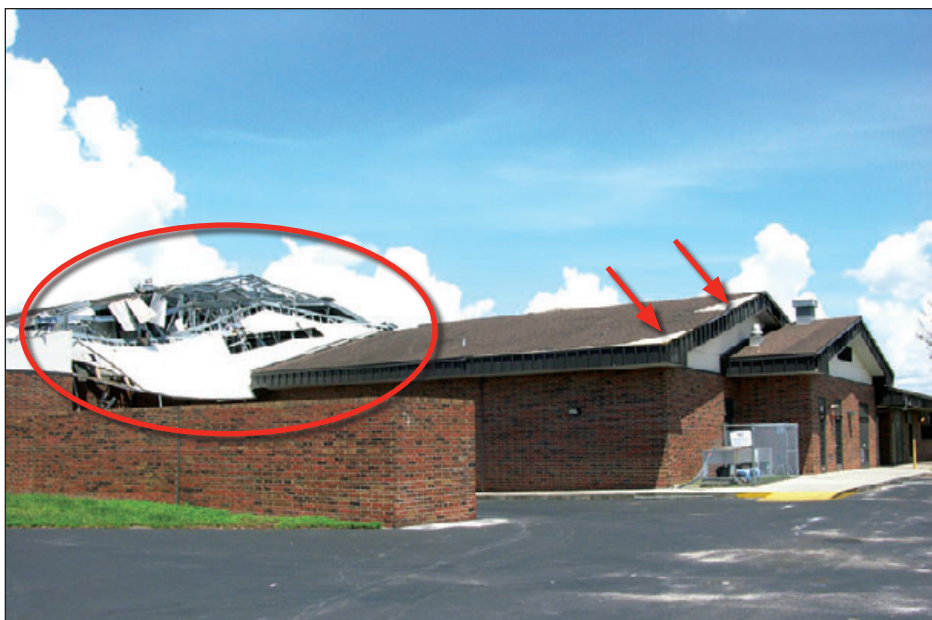
Figure 6-34:
The structure on this school was composed of light gauge metal framing, with a proprietary composite deck system composed of light gauge corrugated metal deck and gypsum board. In addition to the gable end wall failure, the asphalt shingles and underlayment were blown off at the corner of the eave and ridge. Estimated wind speed: 140 to 160 mph. Hurricane Charley (Florida, 2004)

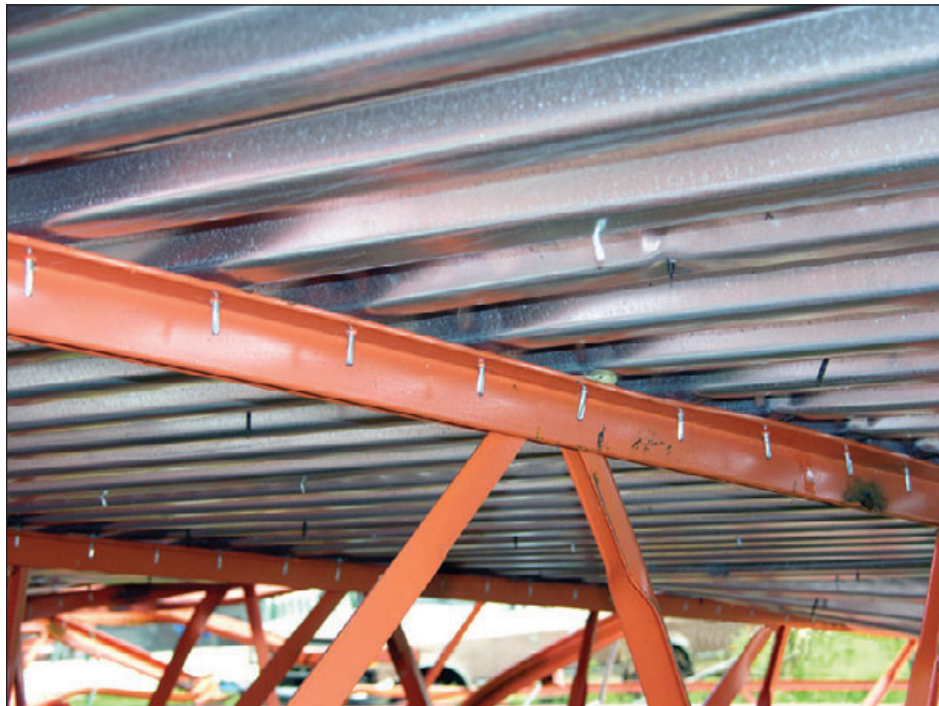
Figure 6-35:
Even though the roof structure blew off, because of the strength and reliability of the screwed deck connections, the decking remained attached to the joists. Hurricane Charley (Florida, 2004)

- For roof decks, concrete, steel, plywood, or oriented strand board (OSB) is recommended.
- For steel roof decks, it is recommended that a screw attachment be specified, rather than puddle welds or powder-driven pins. Screws are more reliable and much less susceptible to workmanship problems, as illustrated by Figure 6-35. These roof joists and decking blew off and landed several feet from the building. The decking was attached with closely-spaced screws. Because of the strength and reliability of the screwed connections, the decking remained attached to the joists.

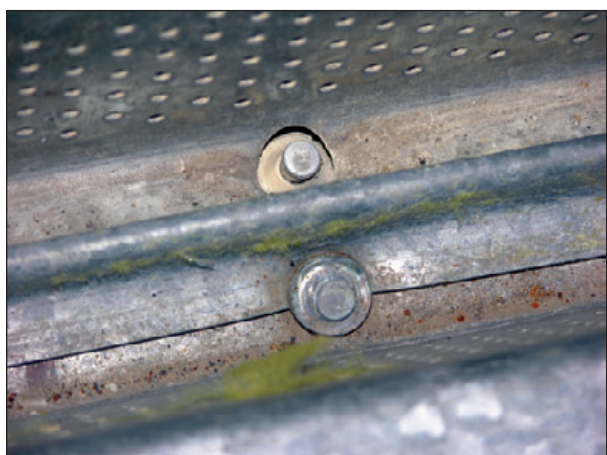
Figure 6-37:
Looking down at a sidelap of a deck attached with powder-driven pins. The washer at the top pin blew through the deck.

Figure 6-36 shows decking that was attached with puddle welds. At most of the welds, there was only superficial bonding of the metal deck to the joist. Only a small portion of the deck near the center of the weld area (as delineated by the circle) was well fused to the joist. Figures 6-37 and 6-38 show problems with acoustical decking attached with powder-driven pins. The pin shown on the left of Figure 6-38 is properly seated. However, the pin at the right did not penetrate far enough into the steel joist below.

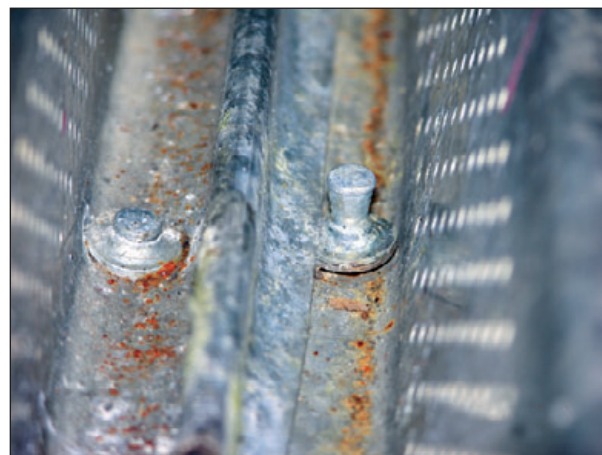
Figure 6-38:
View looking along a sidelap of a deck attached with powder-driven pins. The right pin does not provide adequate uplift and shear resistance.

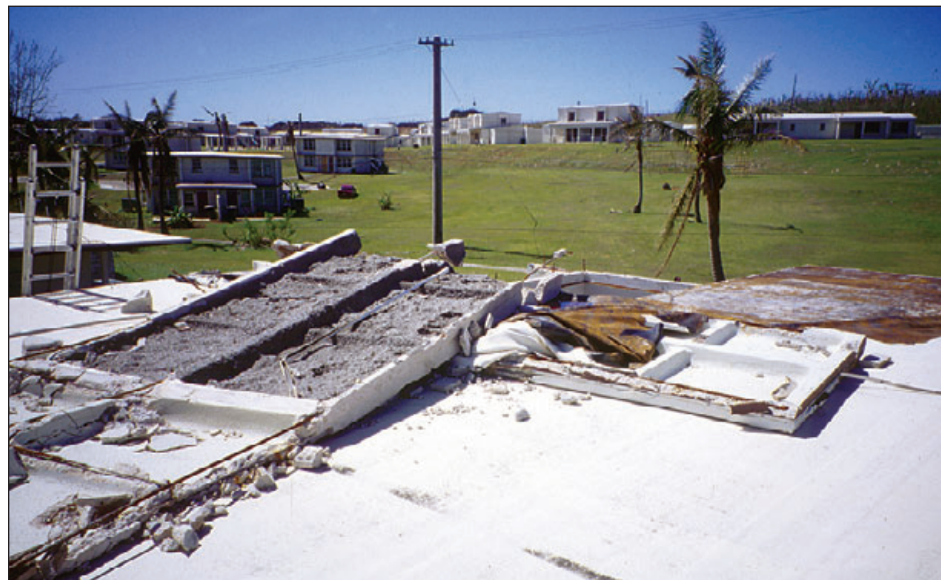
Figure 6-39:
Portions of this waffled precast concrete roof deck were blown off. Typhoon Paka (Guam, 1997)

- For precast concrete decks it is recommended that the deck connections be designed to resist the design uplift loads because the deck dead load itself is often insufficient to resist the uplift. The deck in Figure 6-39 had bolts to provide uplift resistance; however, anchor plates and nuts had not been installed. Without the anchor plates, the dead load of the deck was insufficient to resist the wind uplift load.

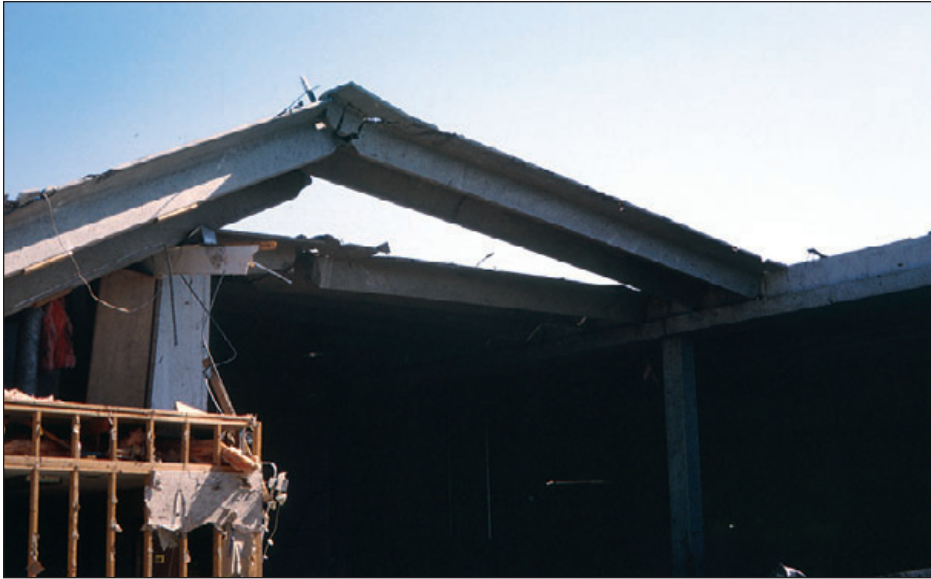
Figure 6-40:
Twin-Tee roof panel
lifted as a result of
the combined effects
of wind uplift and
pre-tension. Tornado
(Missouri, May 2003)

- For precast Tee decks, it is recommended that the reinforcing be designed to accommodate the uplift loads in addition to the gravity loads. Otherwise, large uplift forces can cause member failure due to the Tee's own pre-stress forces after the uplift load exceeds the dead load of the Tee. This type of failure occurred at one of the roof panels shown in Figure 6-40, where a panel lifted because of the combined effects of wind uplift and pre-tension. Also, because the connections between the roof and wall panels provided very little uplift load resistance, several other roof and wall panels collapsed.

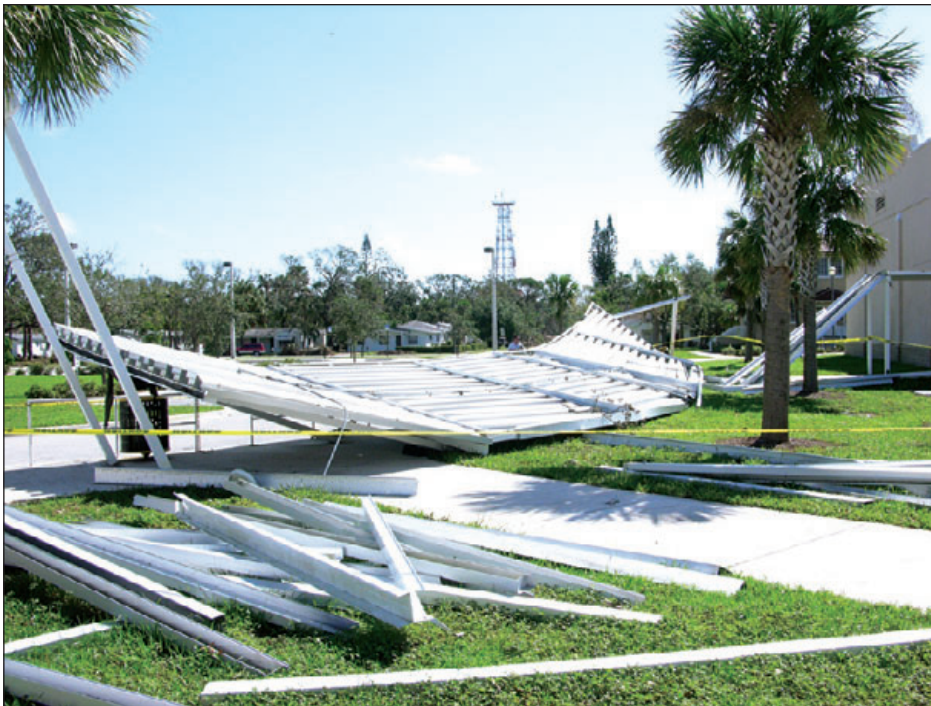
Figure 6-41:
The wind speed was
sufficient to collapse
this school's canopy,
but the speed was not
high enough to blow
the canopy debris very
far. Hurricane Francis
(Florida, 2004)

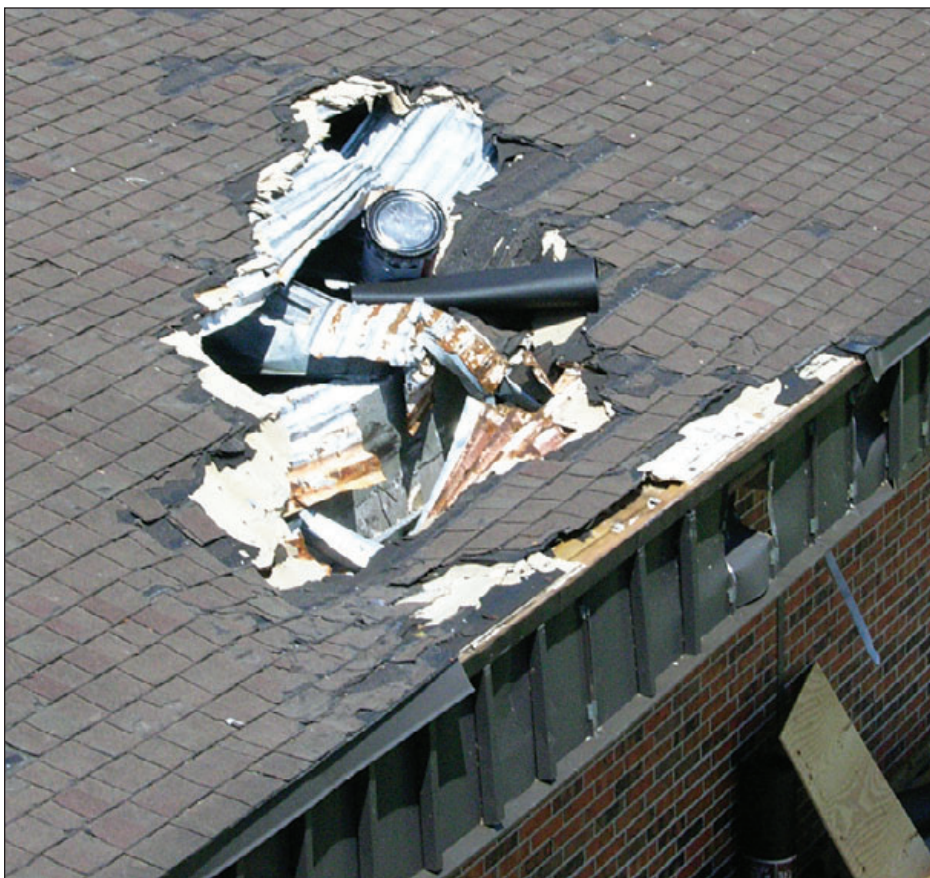
Figure 6-42:
At the school shown in Figure 6-34, wind-borne debris ruptured the proprietary composite deck system composed of light gauge corrugated metal deck and gypsum board. Estimated wind speed: 140 to 160 mph. Hurricane Charley (Florida, 2004)
